PHASE I INSPECTION REPORT
NATIONAL DAM SAFETY PROGRAM

**EAST FORK, ROCK CREEK DAM
(FLINT CREEK PROJECT)
CLINTON, MONTANA
GRANITE COUNTY
MT-15**

PREPARED BY:
CH2M HILL
BELLEVUE, WASHINGTON

MAY 1980

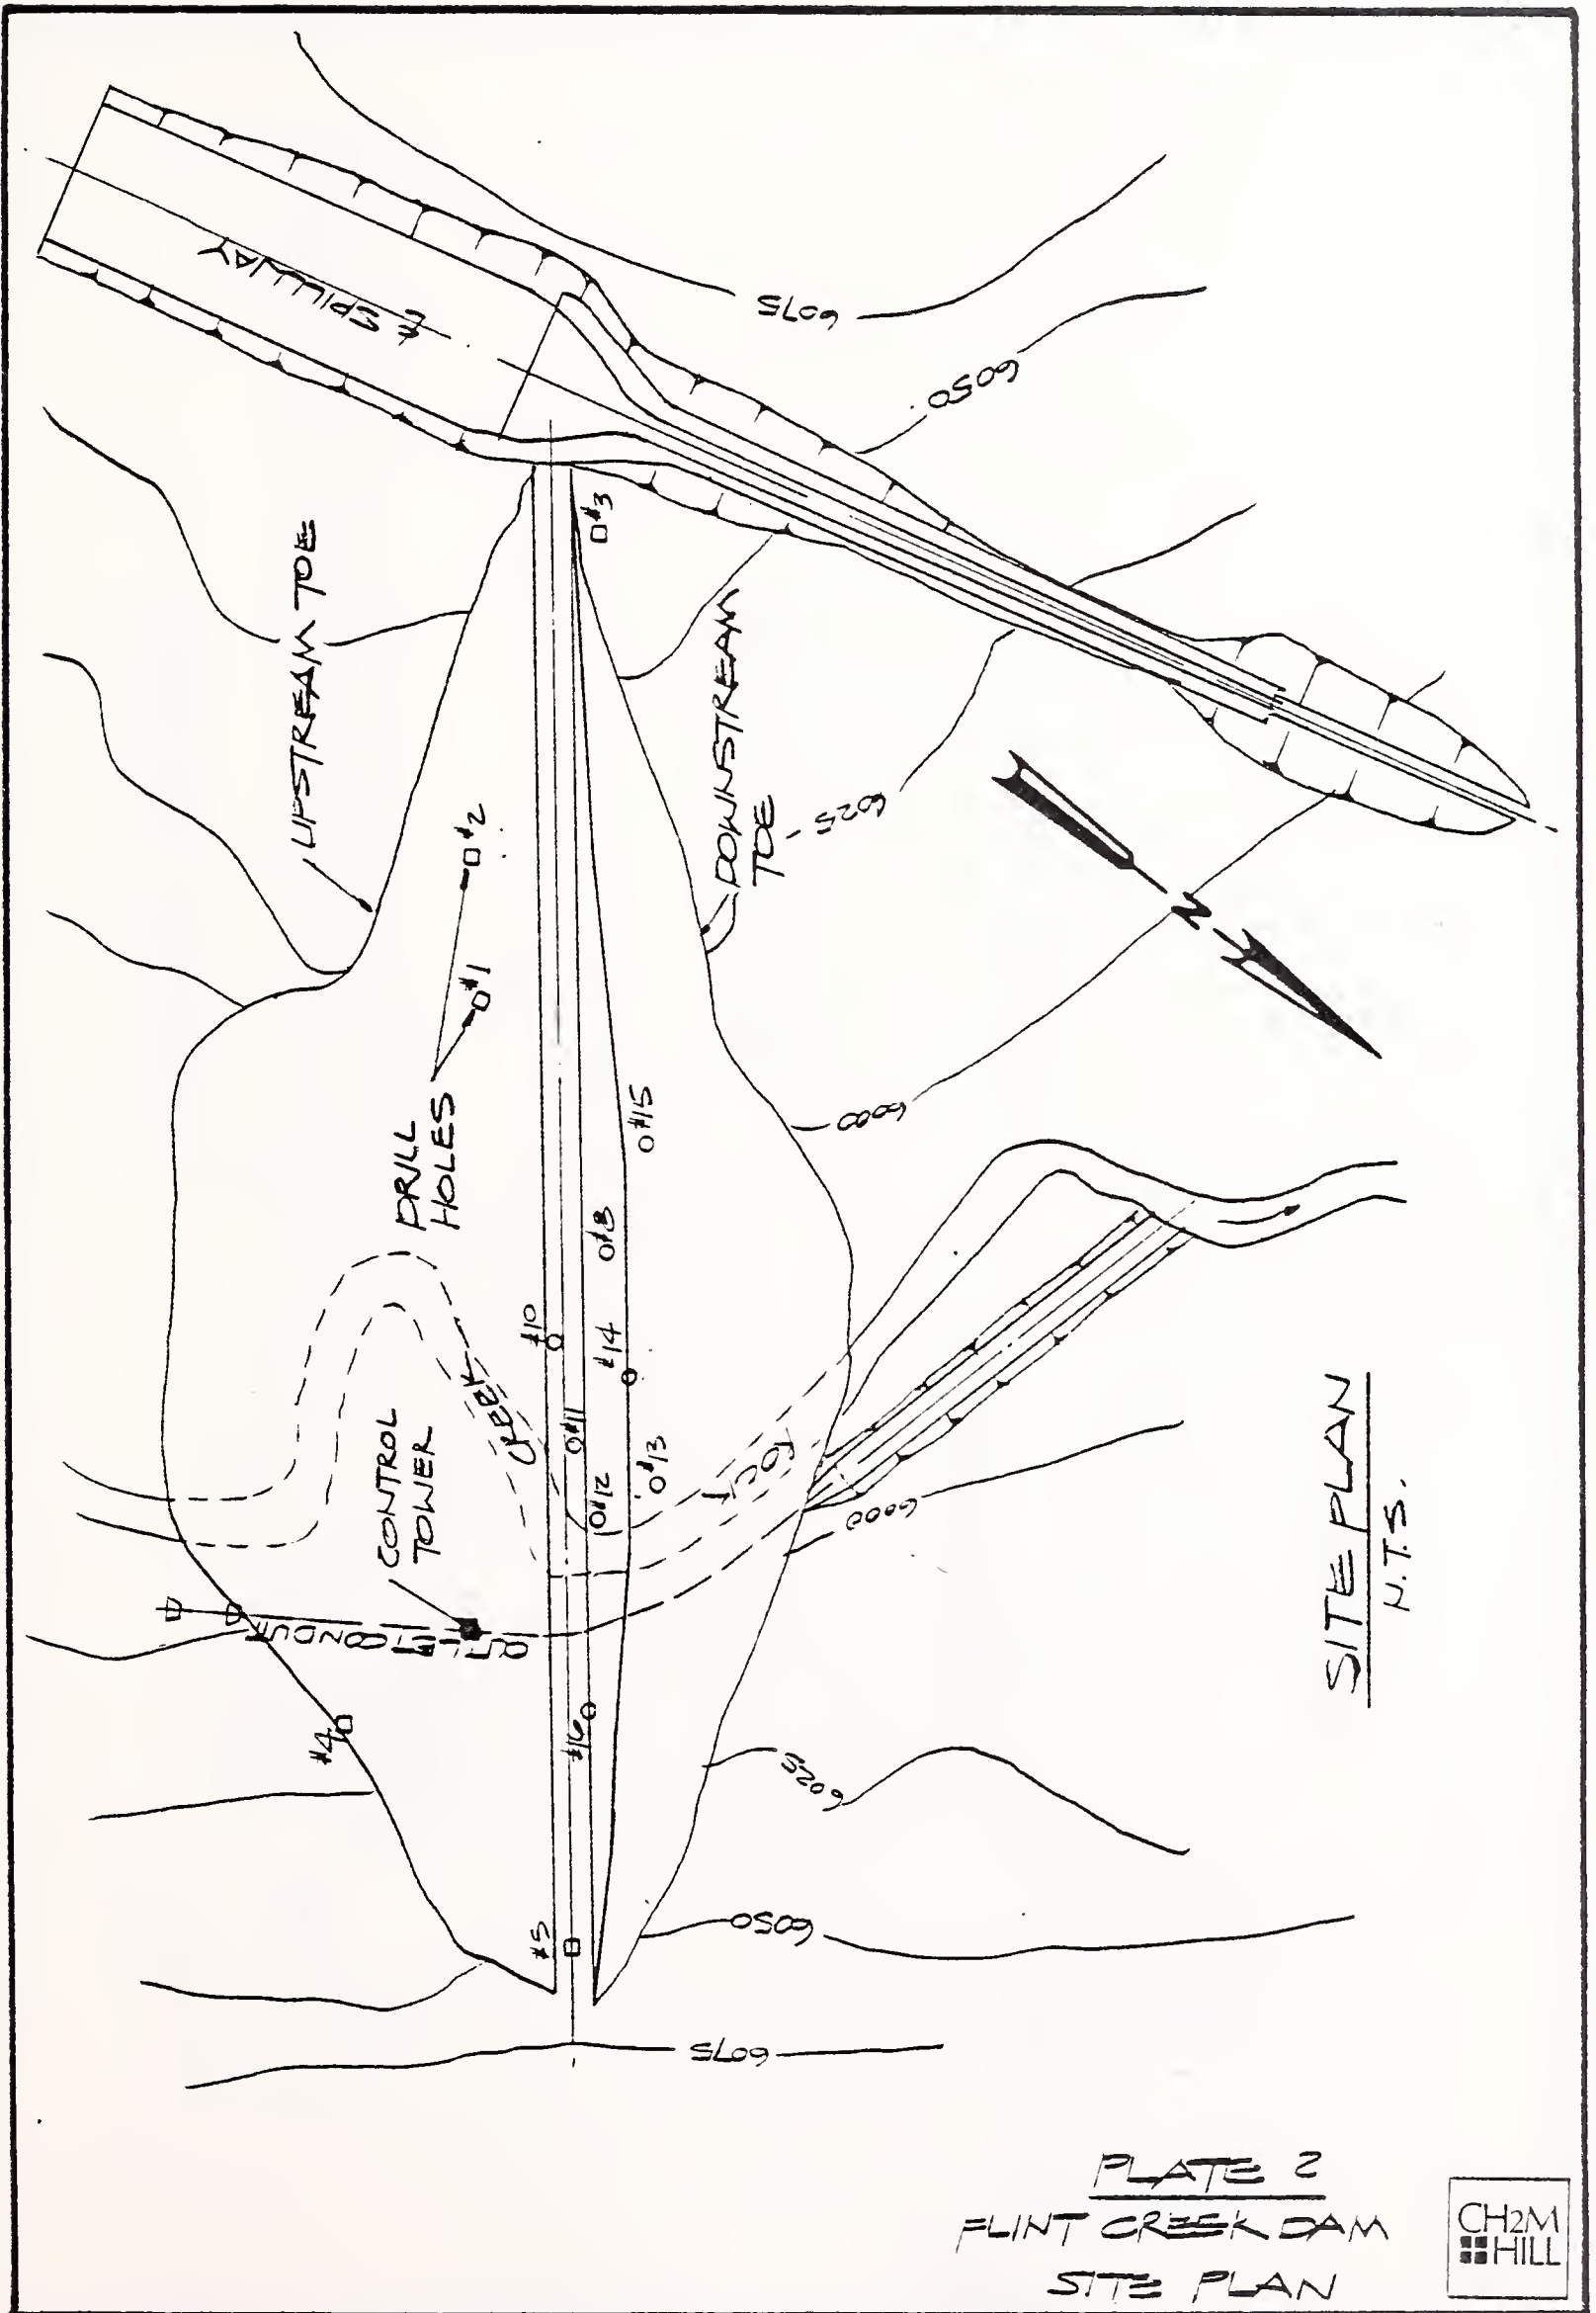
PLATE 2
 FLINT CREEK DAM
 SITE PLAN

The 525-foot-long spillway channel is located on the left abutment, as shown on Plate 2. A 54-inch, horseshoe-shaped outlet with two 54-inch-diameter gates and gate controls at the dam crest is used for irrigation releases.

The outlet structure consists of a pair of walls about 20 feet in length. The walls show considerable spalling caused by freeze/thaw action. The flow discharges to an excavated channel at the end of the outlet structure (Plate 2). The channel is neither eroding nor backcutting.

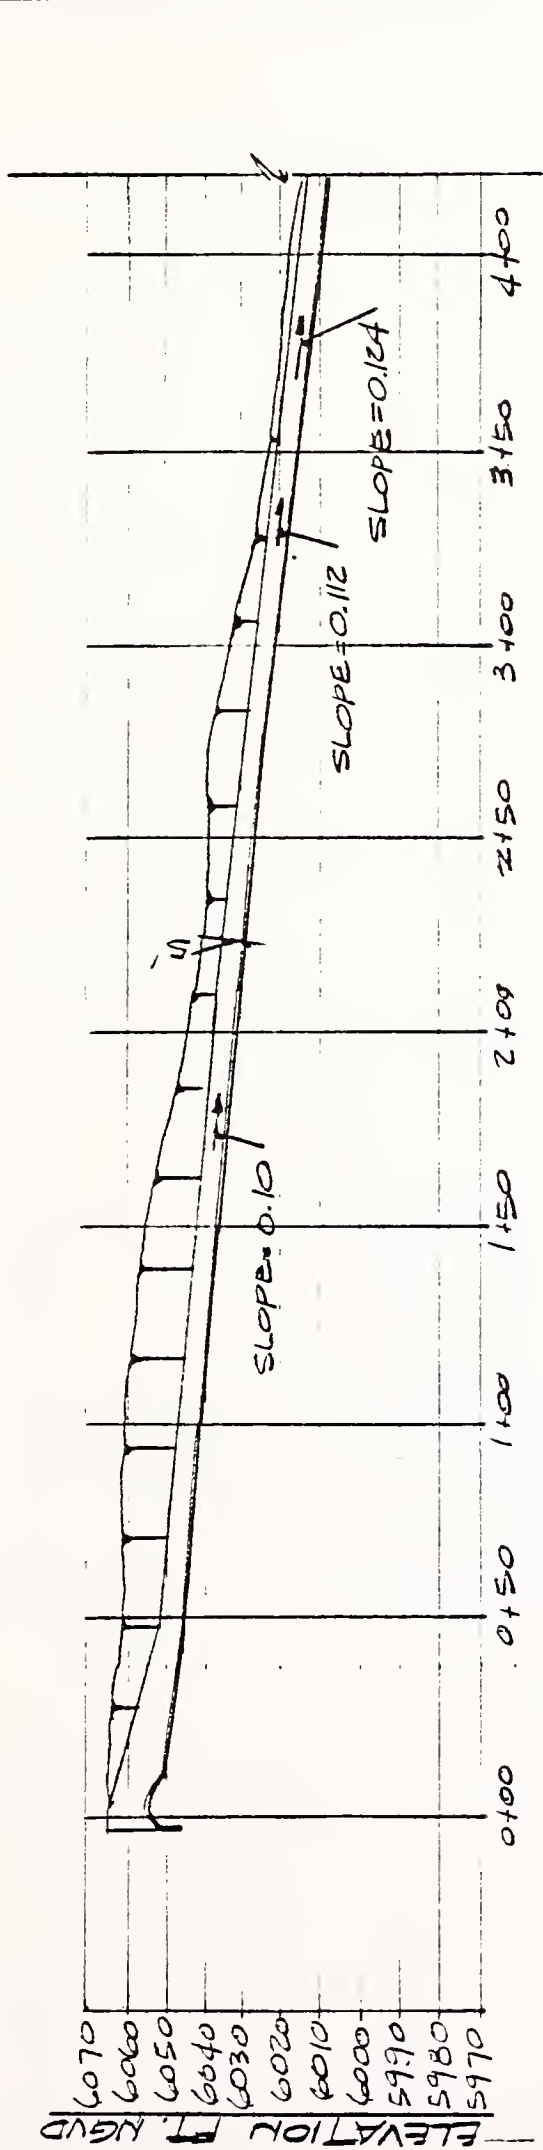
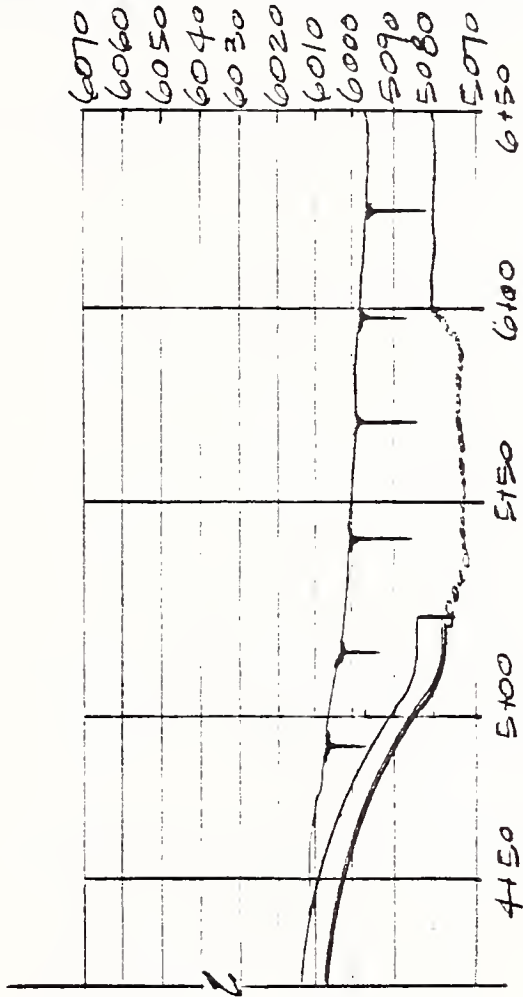
PLATE 4
FLINT CREEK DAM
SPILLWAY PROFILE

The uncontrolled concrete spillway begins as a trapezoidal section with a 50-foot bottom width and 1 V on 1.5 H side slopes (see Photo 1 and Plate 4). A concrete crest, formed to an ogee shape of approximately 5-foot design head, is located in the upstream end of the chute. The apex of the spillway crest is at elevation 6055.5 feet NGVD, 10.1 feet below the low point on the dam crest. The width of the crest at the apex was 60.5 feet. The bottom width of the chute narrows to 21 feet within 50 feet downstream of the crest and to 8 feet within 325 feet downstream of the crest. The bottom width continues at 8 feet for an additional 190 feet to the end of the chute. The concrete of the chute contained minor cracking and spalling and some old deteriorated patches were observed. The slope of the chute varies throughout its 525-foot length, but the total elevation drop is 75.5 feet (Plate 5). The chute ends with a flip bucket. Large riprap exists at the end of the chute and the downstream channel is neither eroding nor back-cutting.

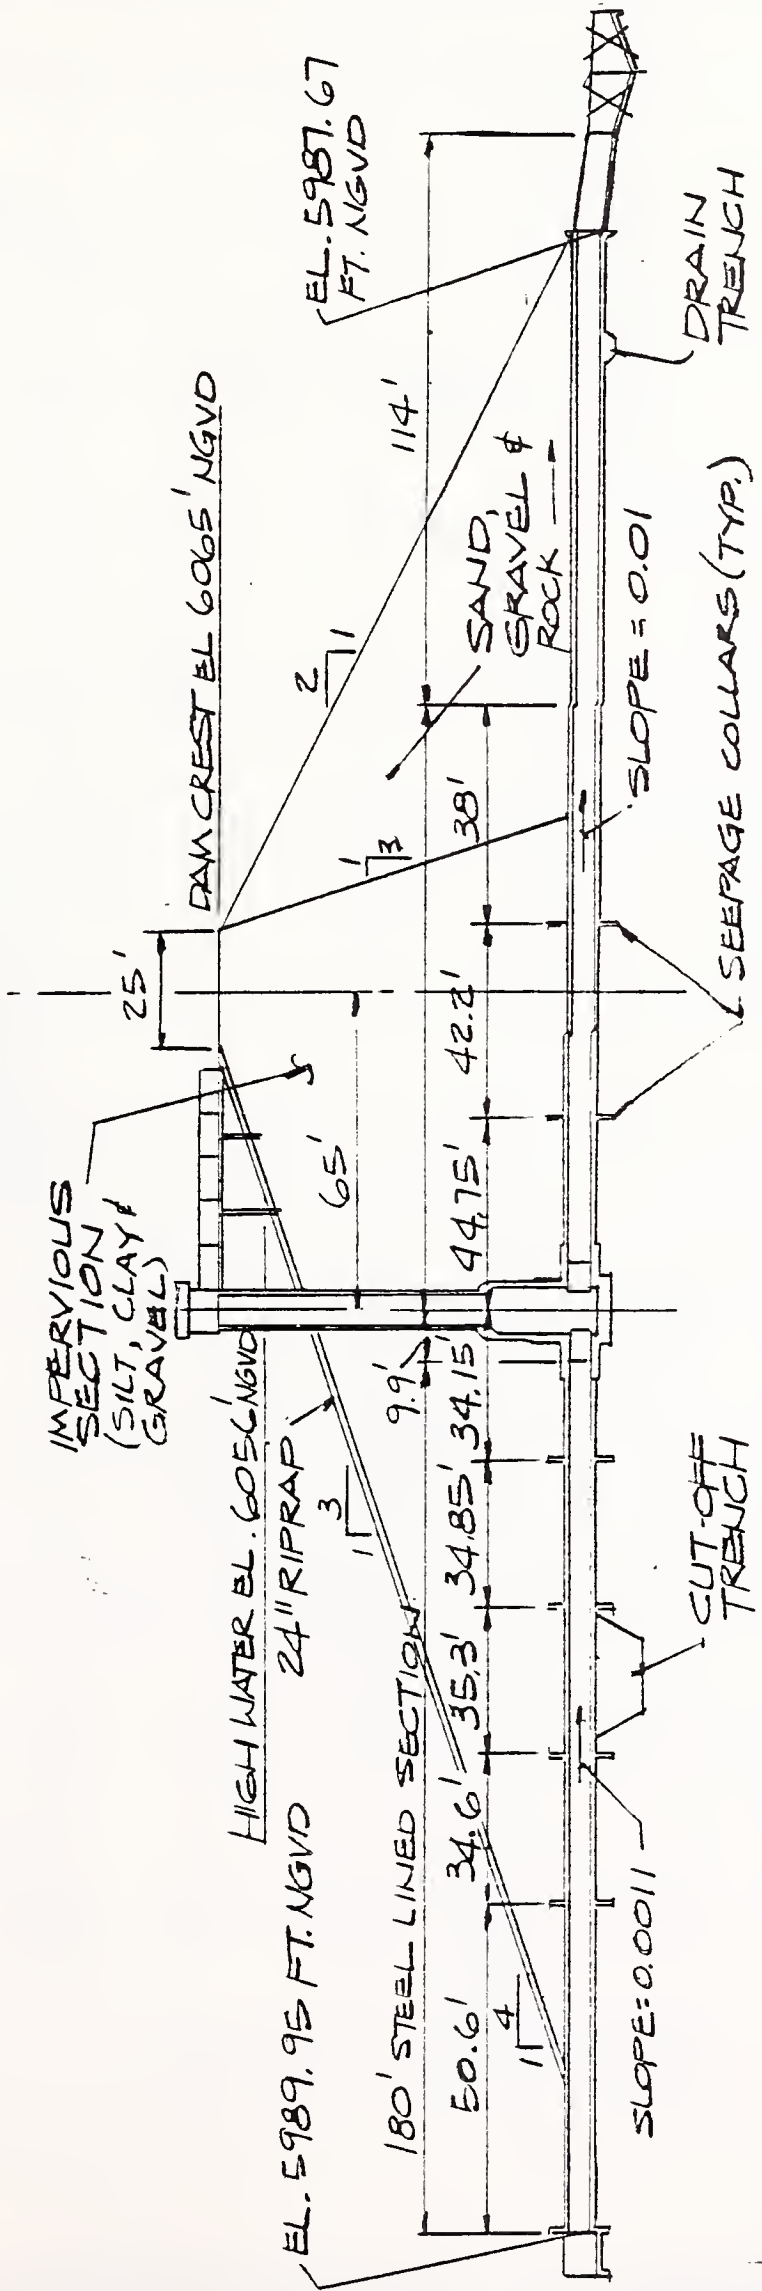
PLATE 7
FLINT CREEK DAM
DAM SECTION

The 87-foot-high, straight-axis, earth, gravel, and rockfill embankment is 1,075 feet long and has a crest width of 25 feet. The downstream slope is 1 V on 2 H and the upstream slope is 1 V on 3 H (see Plate 7). The slope between the upstream impervious zone and the downstream sand, gravel, and rock zone is 1 V on 0.33 H, inclined downstream.
